Intel® Pentium® 4 Processor 6x1 ^Δ Sequence

Specification Update

*– On 65 nm Process in the 775-land LGA Package and supporting
Intel® Extended Memory 64 Technology^φ*

March 2006

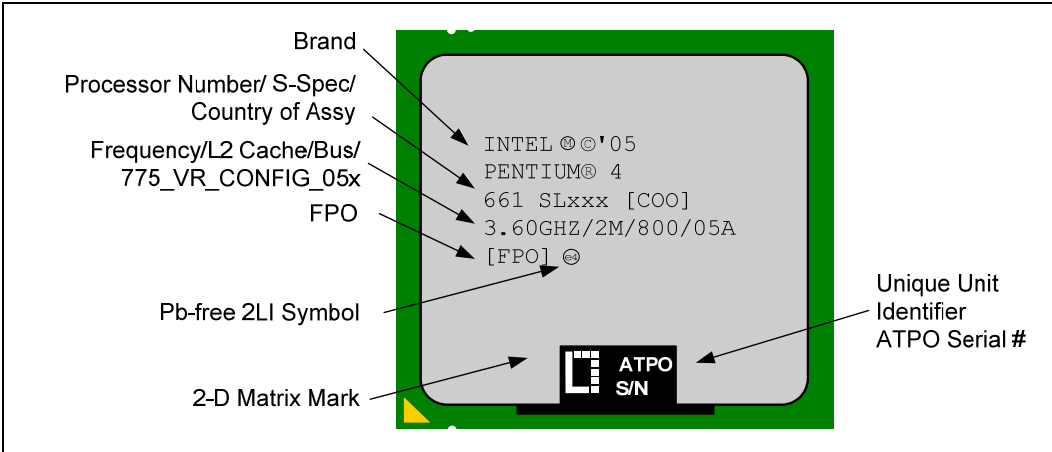
Figure 1. Intel® Pentium® 4 Processor 6x1 Sequence Package (Top Markings)

Version	Description	Date
-001	Initial release	January 2006
-002	Updated related documents, updated processor identification table, and updated figure 1.	February 2006
-003	Added errata AB20, updated processor identification table	March 2006
